Microcontroller Technical Information

RX78K0R 78K0R Real-Time OS Usage Restrictions	Document No.	ZMT-F35-10-0013	1/1
	Date issued	March 30, 2011	
	Issued by	MCU Tool Product Marketing Department MCU Software Division MCU Business Unit Renesas Electronics Corporation	
Related documents None	Notification classification	√	Usage restriction
			Upgrade
			Document modification
			Other notification

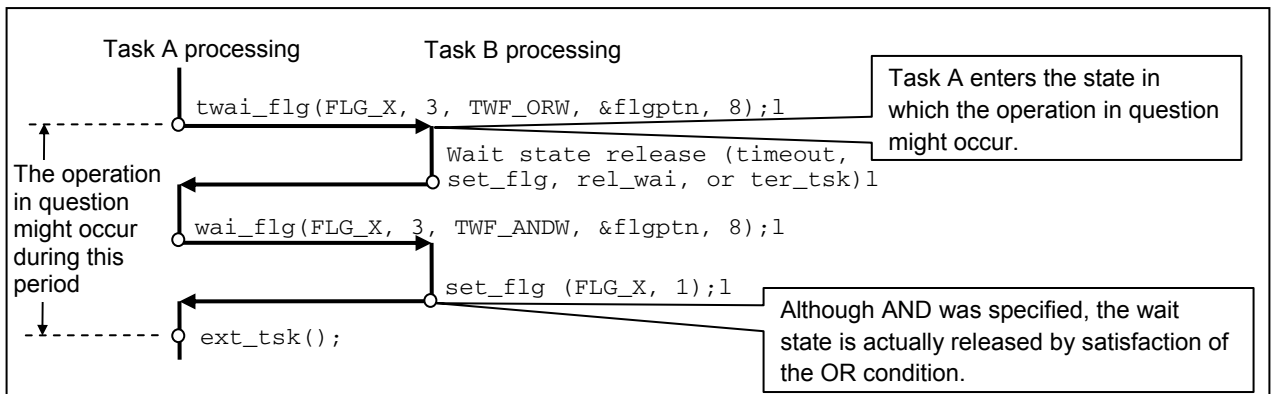
Example 1:

When the service call `wai_flg` or `twai_flg` is issued multiple times with both OR and AND specified at least once as the bit pattern checking condition for the same event flag during processing of the same task, if a subsequent service call is issued with AND specified, the condition might be handled as OR.

Although AND is specified as the condition for releasing the wait state in 2, the wait state is actually released by satisfaction of the OR condition.

Do not specify AND and OR together as the wait conditions for the same event flag during processing of the same task.

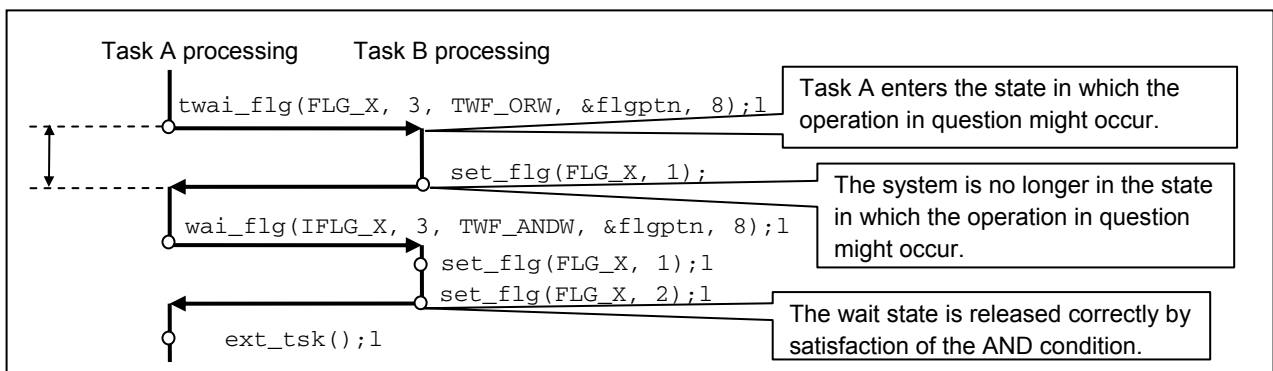
Example 2:

To recover from the state in which the operation in question might occur, issue `ext_tsk` or `ter_tsk` for the relevant task, or initialize the operating system. For example, this operation does not occur if the wait state is released by issuing `set_flg` as follows:

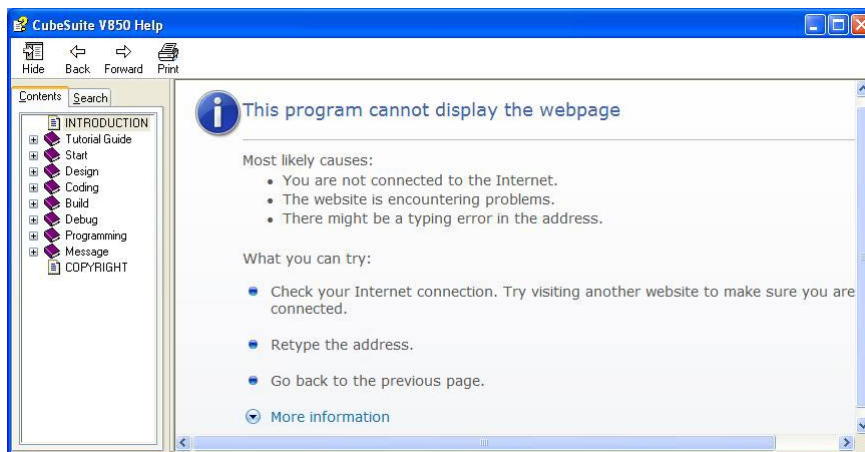
If the **F1** key is pressed while the cursor is pointing to a message output by the build tool in an RX78K0R project, the **Help** menu does not open with an appropriate explanation. Instead, the following **Help** message is displayed:

On the menu bar, click **Help** and then **Help for CubeSuite** to open the **CubeSuite Help** dialog box.

Search for the appropriate **Help** message in this dialog box.

This issue has been corrected in Realtime OS Build Tool Plug-in (Common) Ver. 1.01.
